VCR Service Bulletin

VCR 95-016

MODELS: VR332, VR528, VR538, VR539, VG4038 AND VG4039

TOPIC: DP026/DP027 DIODE FAILURES

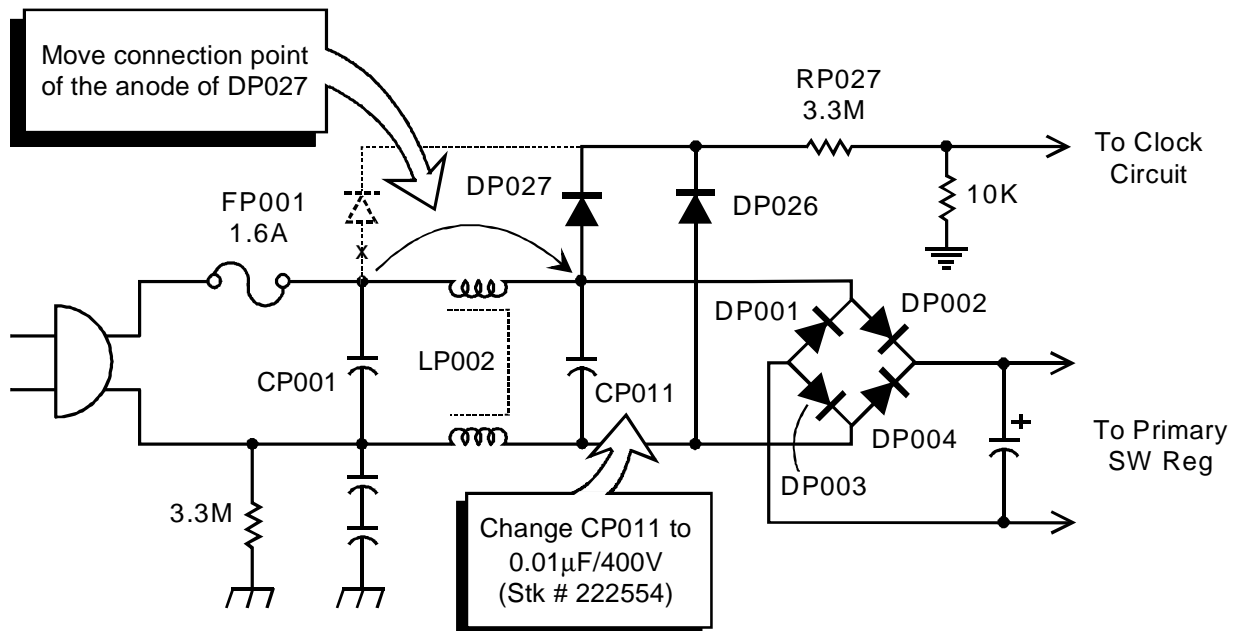
Symptom: VCR is completely dead.

Cause: Fuse, FP001 found to be open and diodes, DP026 and DP027 shorted.

Cure: Perform the circuit modification described below to improve the ability of diodes, DP026 and DP027 to handle higher line voltage surges. When replacing defective diodes, DP026/DP027 and fuse, FP001, use **modification kit, stock # 231734** which includes two diodes, one fuse and a new value capacitor for CP011. See the schematic below and board view on the reverse side.

1. Re-locate the connection point of the anode of the original diode, DP027 (per drawing below and on the reverse side).
2. Replace CP011 with the a new value capacitor (stk # 222554).

Note: Both the re-location of DP027 and installation of a new value CP011 must be performed to increase the protection for DP026 and DP027.
